**DEBRIS CONTROL AT HYDRAULIC
STRUCTURES IN SELECTED AREAS
OF EUROPE**

N. Wallerstein & C. R. Thorne

University of Nottingham,
Department of Geography,
Nottingham, England

First Interim Report

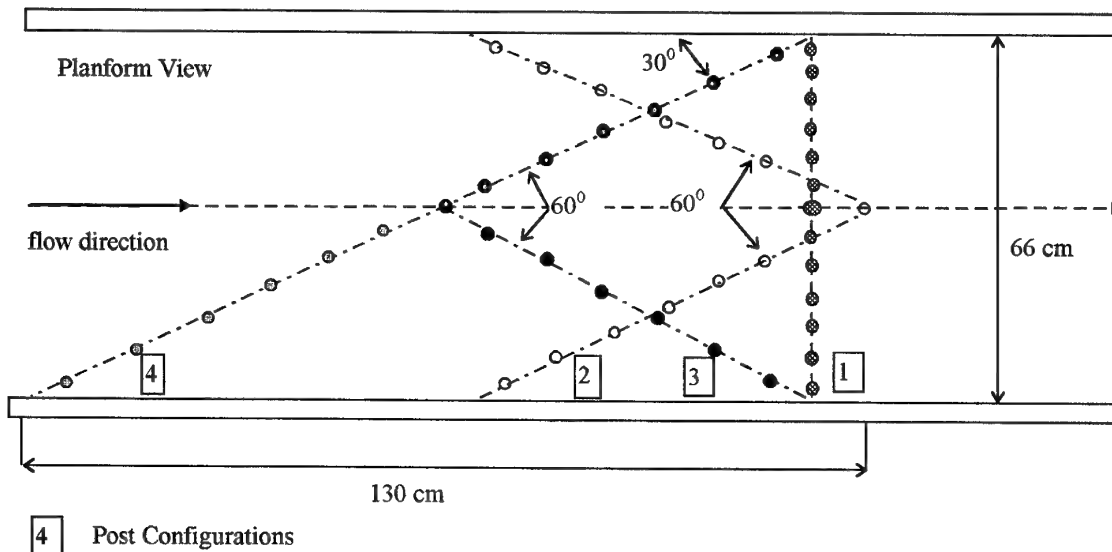
Figure 1.1 Tested flume post alignments. Modified from Knuass (1985).

bridges and reduce the potential for overbank flows in downstream areas. A number of physical model tests were carried out at the Hydraulics Laboratory. It was found that the best method for retaining debris, while allowing the downstream movement of water and sediment, was to use circular posts set into the channel bed, with a post spacing set to the minimum length of debris that it was desired to trap. A number of different post configurations were tested in a rectangular perspex flume to determine the best alignment for retaining the imposed debris load and for passing the designed discharge with minimum backwater effect (figure 1.1). It was found that alignment 2 (a downstream pointing "V") was the configuration with the best debris retention capacity and which had the least backwater effect when the device was filled with debris. Configuration 1 was found to be unsatisfactory because debris tended to be pushed up over the barrier, while the smaller barrier length than in configuration 2 meant that the flow had less area to pass through the structure so that the backwater effects were greater. Configurations 3 and 4 created less backwater effect than 1 but slightly more than configuration 2.

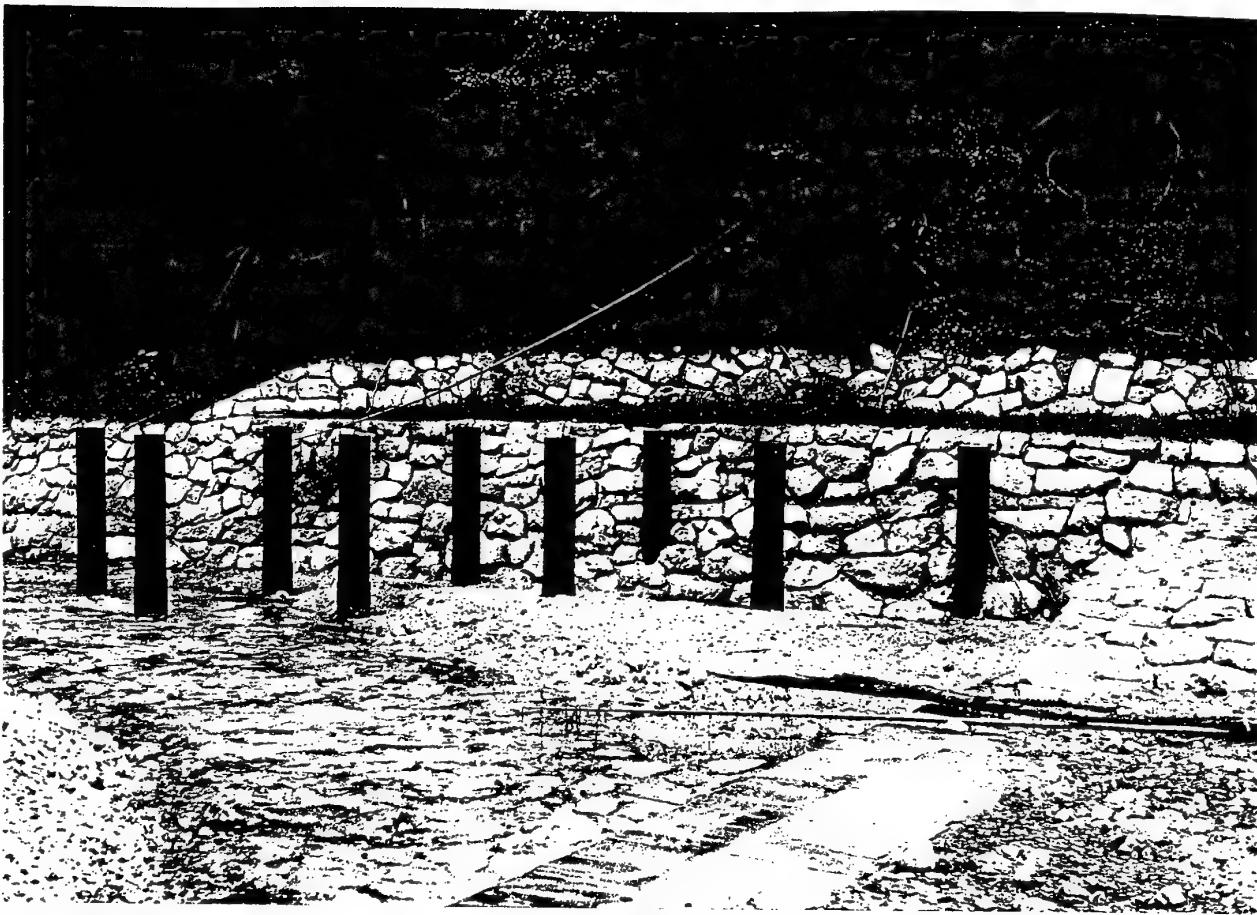
Plate 3 : Treibholzfang device on the river Lainbach. View downstream.

The prototype on the Lainbach was completed in 1993 and was, at the time when visited (October 1995), being cleaned of a large sediment bar deposit which had accumulated upstream of the posts. The device on the Arzbach is currently under construction. The estimated cost of the device on the Lainbach, without maintenance costs, is DM 2 million (\$1.5 million). Plates 3 and 4 show the prototype device on the Lainbach.

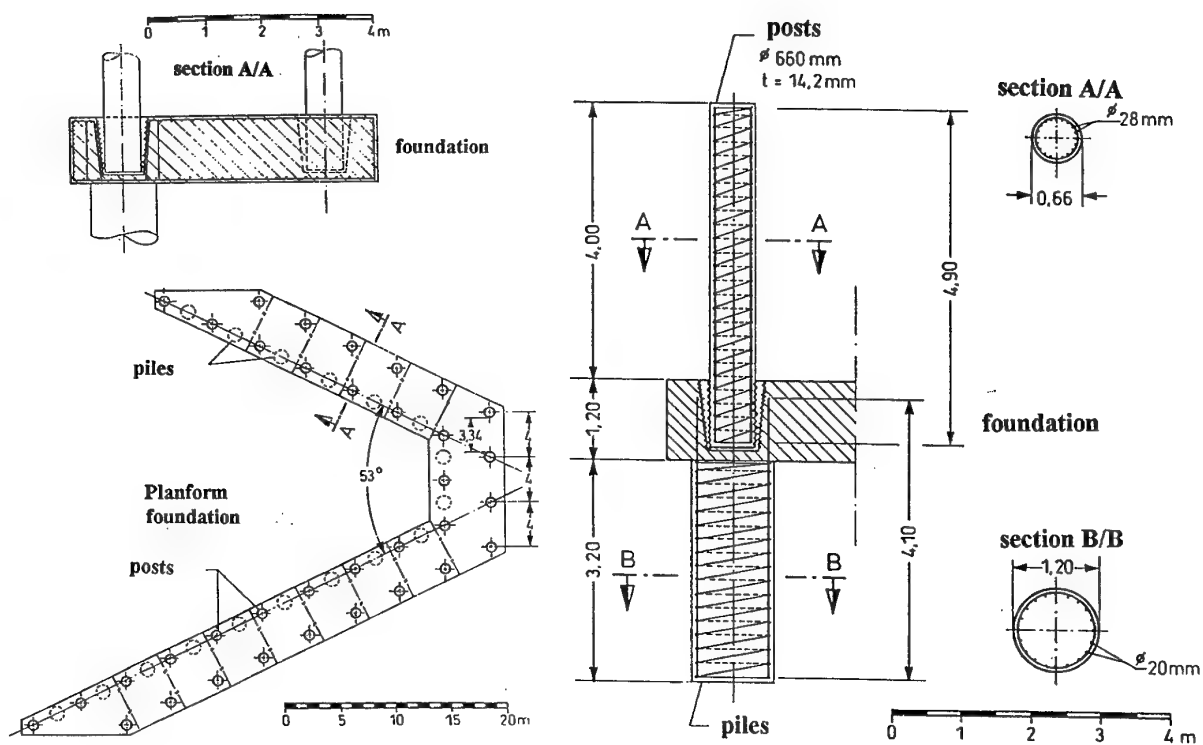
Figure 1.3 : Construction details of posts and foundations on Lainbach Treibholzfang (modified from Knauss, 1985).

The Lainbach device has a double row of posts, but this was later found to be unnecessary and the Arzbach device, therefore, only has a single row. Post dimensions are 0.66m diameter and 4 m high above the channel bed and each post consists of a steel sleeve with concrete core. Each post is set into a concrete foundation which is

supported on pilings sunk 4.4m into the ground. The posts are set into the middle of a basin built with massive close fitting stone blocks on both the bed and banks to prevent scour. Figure 1.3 shows the constructional details of the posts and foundations. The device on the Arzbach also has an energy dissipation pool downstream of the posts (see figure 1.4). Both structures will be cleaned periodically of debris and sediment although the Arzbach device has a central in-cut low flow channel designed to flush accumulated sediment downstream at low flow to avoid starving the downstream areas of the sediment load necessary to prevent channel degradation.

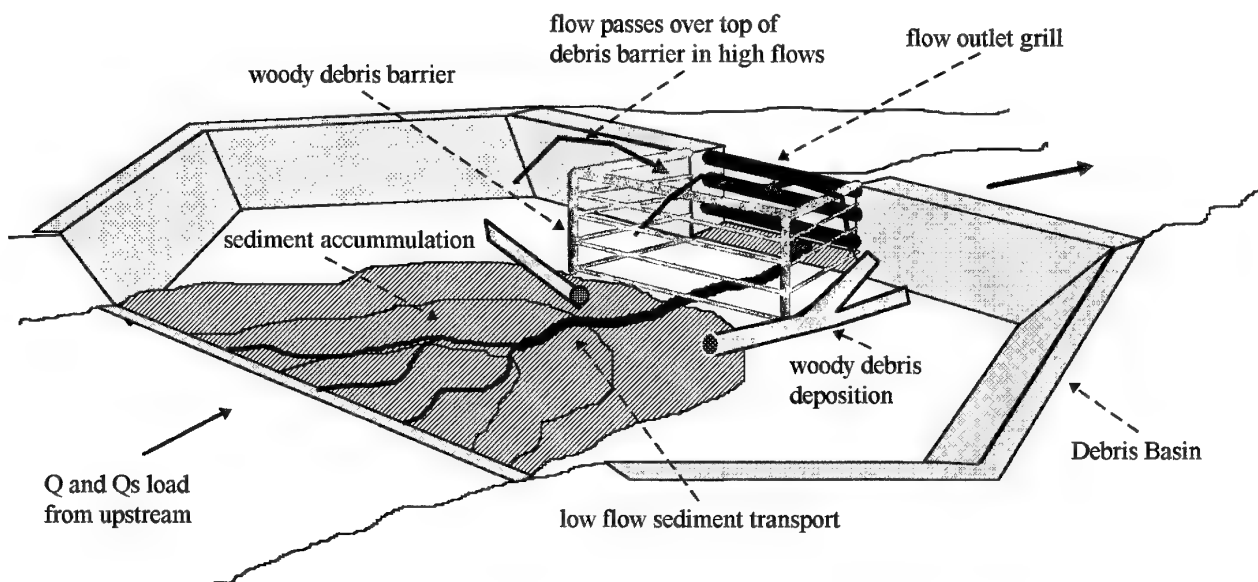
Figure 1.5 : Debris retention basin with woody debris protection device.

Debris detention basins are small pools which have no continuous backwater designed to trap sediment and debris washed down by torrents from the steep flanks of Alps and are installed to protect roads and other structures in their path. The basins have small outlets at the front, so that the accumulated sediment can be flushed out by degradation at low flows. A major problem, however, is that woody debris can block the outlet grill of the basin, so that sediment flushing does not occur resulting in the structure being overtopped during flood events. The solution to this problem has been to construct slanting gridded weirs or box type trash racks around the upstream side of the outlet grill so that during storm events the flow can pass over the top of the trash rack and out through the grill plate. See Figure 1.5

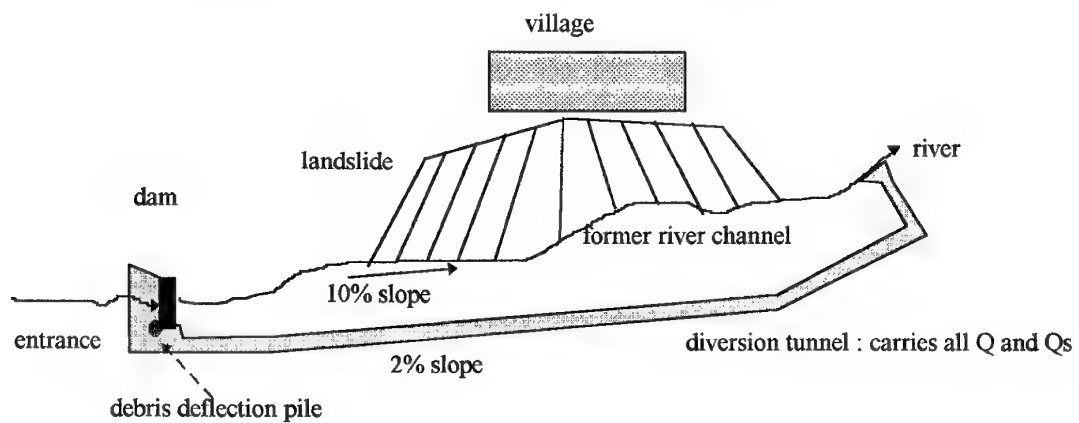
Figure 1.6 : Schematic diagram of the Campo Vallemaggia diversion tunnel .

The tunnel is 2km long, has a bed slope of 2% in order to prevent abrasion (while the local channel slope is 10%) and is designed to pass the 200 yr. flood (300 cumecs) (figure 1.6).

The solution tested to prevent the tunnel from clogging by woody debris was the construction of a steel and concrete pile (2.4m in diameter) upstream of the tunnel entrance to rotate debris parallel with the flow direction into the tunnel. Model test runs were carried out with/without debris and landsliding events upstream were simulated. The results showed that more debris was rotated parallel with the flow when the pile was present than when it was removed. Smaller debris was found not to accumulate in the tunnel. One problem encountered in the tests was that of scaling between the model and the prototype, as the simulated debris has far less elasticity than that found at the prototype. The pile was initially designed with a sloping, pointed upstream side, but this was found to offer a negligible improvement in efficiency as compared with a simple, and cheaper, cylindrical pile.

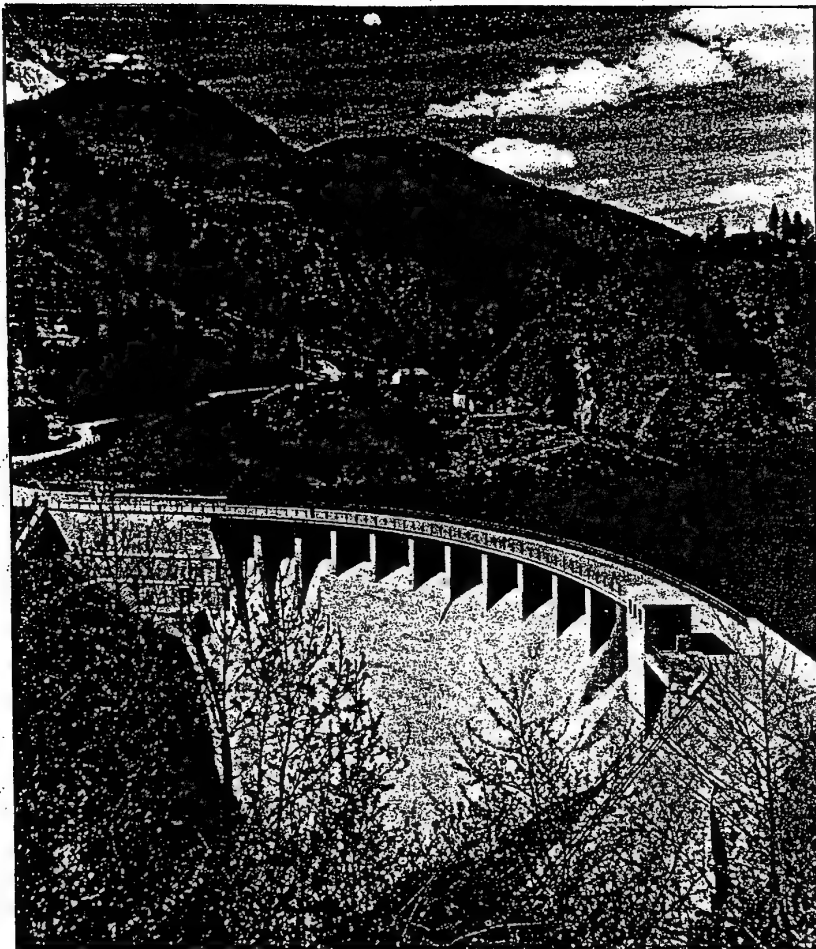
**Plate 5 : Palagnedra dam prior to remodelling of spillway
(after Vischer & Trucco, 1985).**

catchment area of 140km^2 , over 50% of which is forested and lies on steep slopes. The structure consists of an arched gravity dam, 120m long and 72m high and a 45m high diaphragm wall built within morainic material in a secondary valley. The flood spillway had an uncontrolled ogee crest on top of the dam and steep chute terminated by a ski jump. The crest was divided into 13 openings, the boundary walls of which functioned as piers for an overlying road. The nominal discharge capacity of this spillway was $450\text{ m}^3/\text{s}$. (Plate 5).

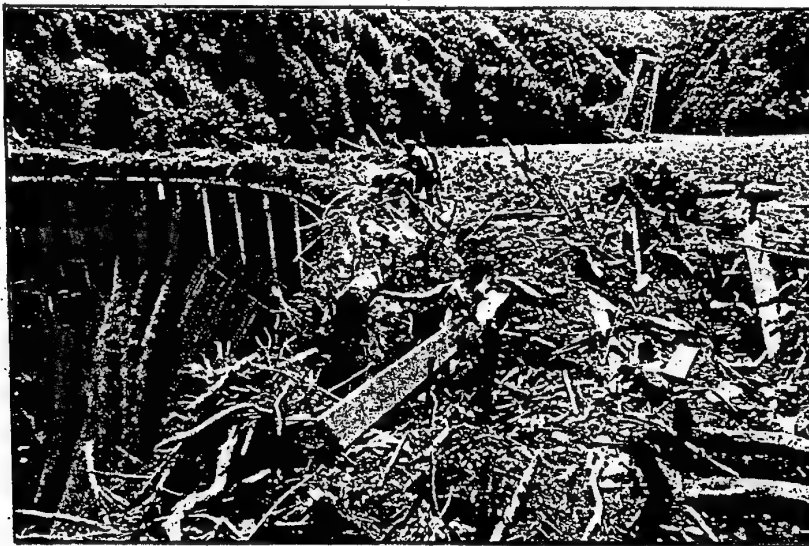
**Plate 6: Dam choked with debris on the morning of August 8th, 1978
(after Vischer & Trucco, 1985).**

On 7th August 1978 an extreme storm event occurred in the region causing a flood wave to pass down the Melezza river to the dam carrying a huge quantity of logs and wooden debris (later estimated to be about 25000m^3 of wood). About $1.8 \times 10^6\text{ m}^3$ of sand and gravel were also transported into the reservoir. Debris build-up at the spillway partially obstructed the openings and caused the dam to overtop over its entire length. The peak discharge at the spillway was estimated to be just under $2000\text{m}^3/\text{s}$. Plate 6 shows the dam choked with wooden debris on the 8th August 1978 after the flood event. The main dam suffered insignificant damage, but about 50000m^3 of morainic material was eroded from the downstream side of the diaphragm wall which seriously endangered its stability. In the aftermath of the event a study was carried out to try and piece together the sequence of events that took place and to understand the meteorological and hydrological conditions necessary to cause the flood wave and associated debris build-up. The dam spillway was then remodelled and the design tested with new discharge levels and a simulated debris load at the Laboratory of Hydraulics, Hydrology and Glaciology, at the Federal Institute of Technology in Zurich. The remodelled spillway had to satisfy a new design discharge of $2,200\text{m}^3/\text{s}$, the avoidance of woody debris build-up at the weir

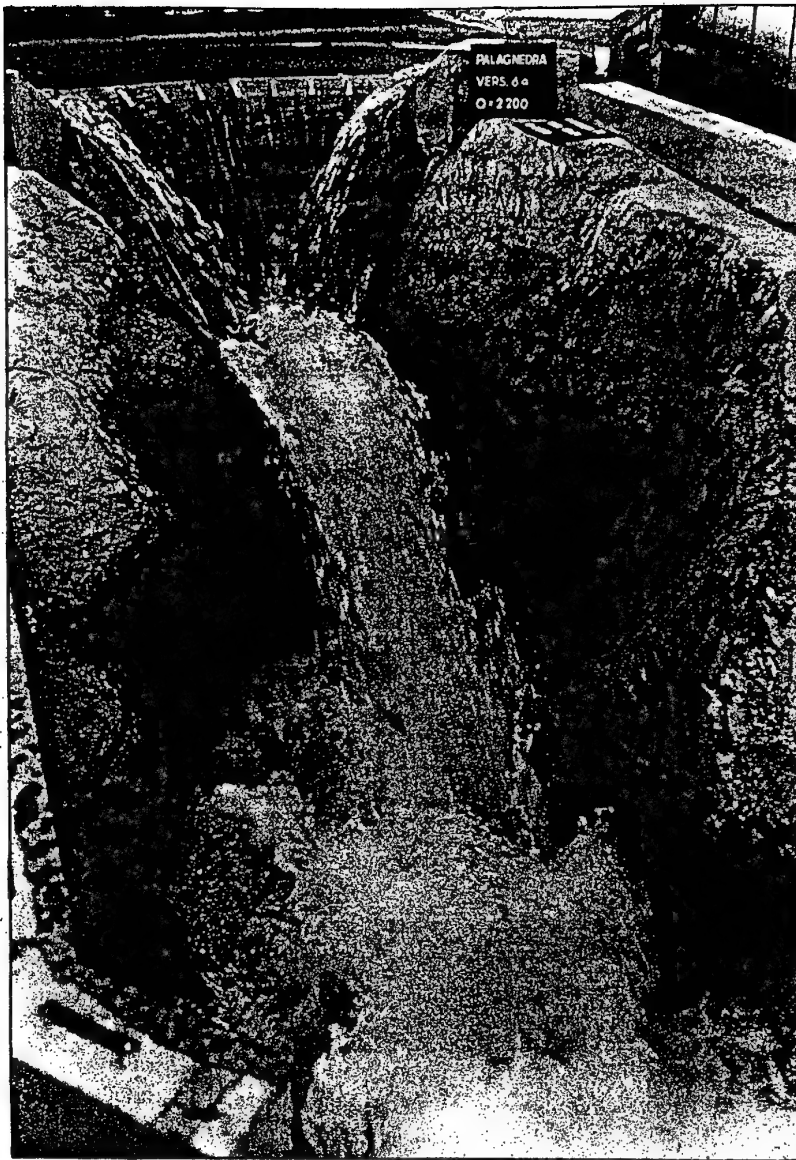
Plate 7 : Physical model (scaled 1:50) with remodelled spillway. Discharge 2.200 m³/s (after Vischer & Trucco, 1985).

crest and satisfactory flow conditions over the weir crest and ski-jump and in the downstream canyon. Measures tested in the physical model and implemented were:

- Raising the abutments by 4m to prevent overtopping.
- Removal of the dam top bridge and supporting piers to leave a continuous weir crest.
- Raising and remodelling of the spillway guidewalls to ensure undisturbed discharge of the increased runoff. Plate 7 shows the scale model with new spillway design.

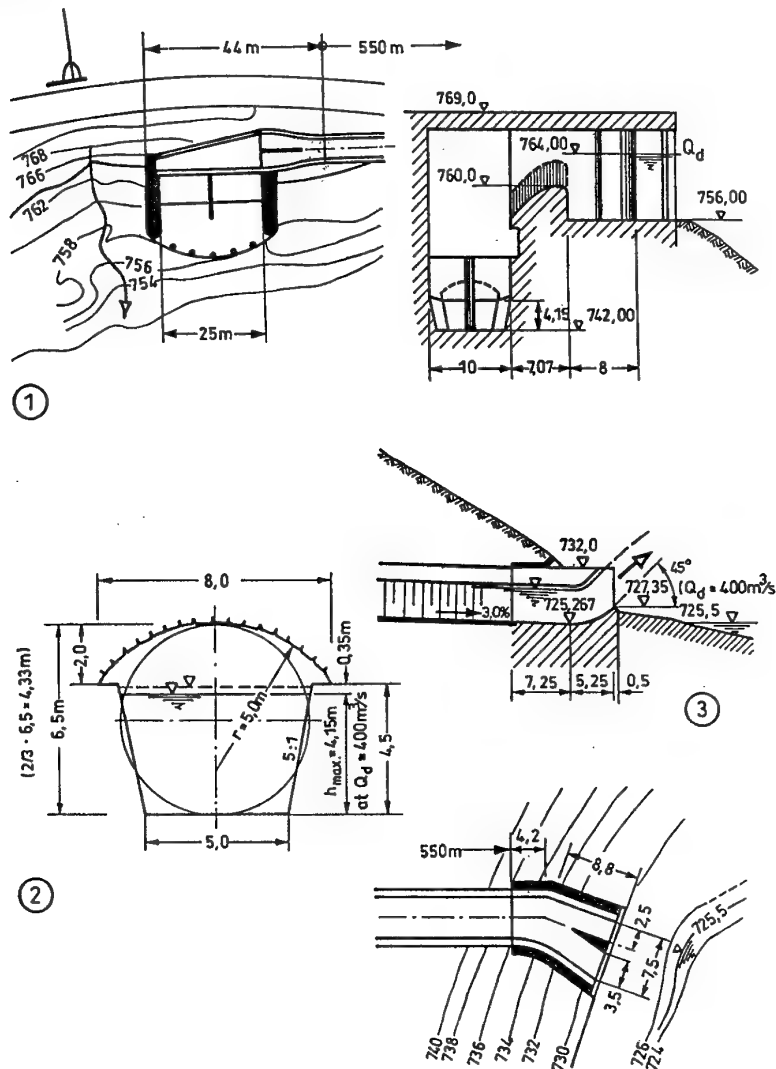
Figure 2.1 Structural details of the spillway for the Sylvenstein Dam (from Knauss, 1985).

- ① Overspill and intake structure, lay-out and cross section
- ② Cross section of the tunnel
- ③ Flip bucket, lay-out and cross section

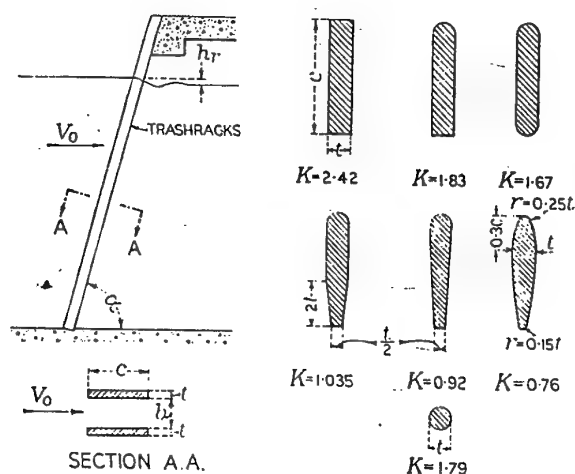
Figure 4.1 : K factor values for various bar shapes (after Zowski, 1960).

K = factor depending on bar shape. See figure 4.1.

A variety of bar shapes are shown in figure 4.1. Flat bar ends are usually adequate, while the use of streamline shapes is seldom justified from an economic standpoint. For hydraulic considerations however bars should be as thin as possible although it is not advisable to use bars less than 9.5 mm. thick to avoid damage from handling and debris impact. For deeply submerged intakes bars not less than 12 mm. thick should be used. The depth of bars is determined by structural requirements but to permit raking it should be made sufficient to provide 38 mm depth between the upstream face and back support struts.

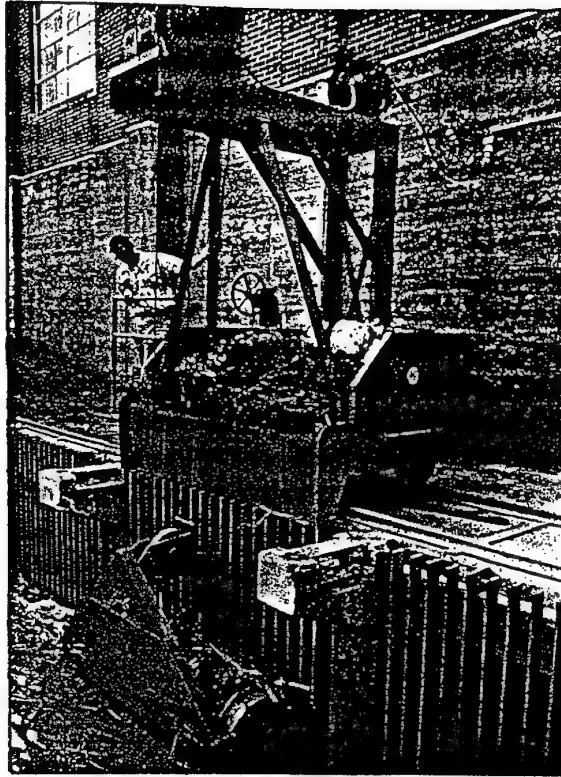
Plate 10 : Leonard type rake with combined hoist, trash car and apron (after Zowski, 1960).

One example of an unguided rake is the Leonard type rake which is commonly used in the USA. This rake has a series of teeth on an axle which rotates through 90° from vertical to horizontal when the rake reaches the bottom of the rack so that debris is not pushed to the bottom as the rake moves downwards. At the top of the rack the rake is guided to the unloading position by a curved apron which prevents the loss of debris. This apron also supports the rake as it traverses from one bay to the next. Plate 10 shows a Leonard rake supported on a combined hoist, trash car and apron. Another example of an unguided rake is the Glenfield plough which ploughs through the debris on its downward travel and on the upward travel the debris thus dislodged is caught in the basket formed by the upper part of the rake. Plate 11 shows a plow rake suspended from an intake gantry crane.

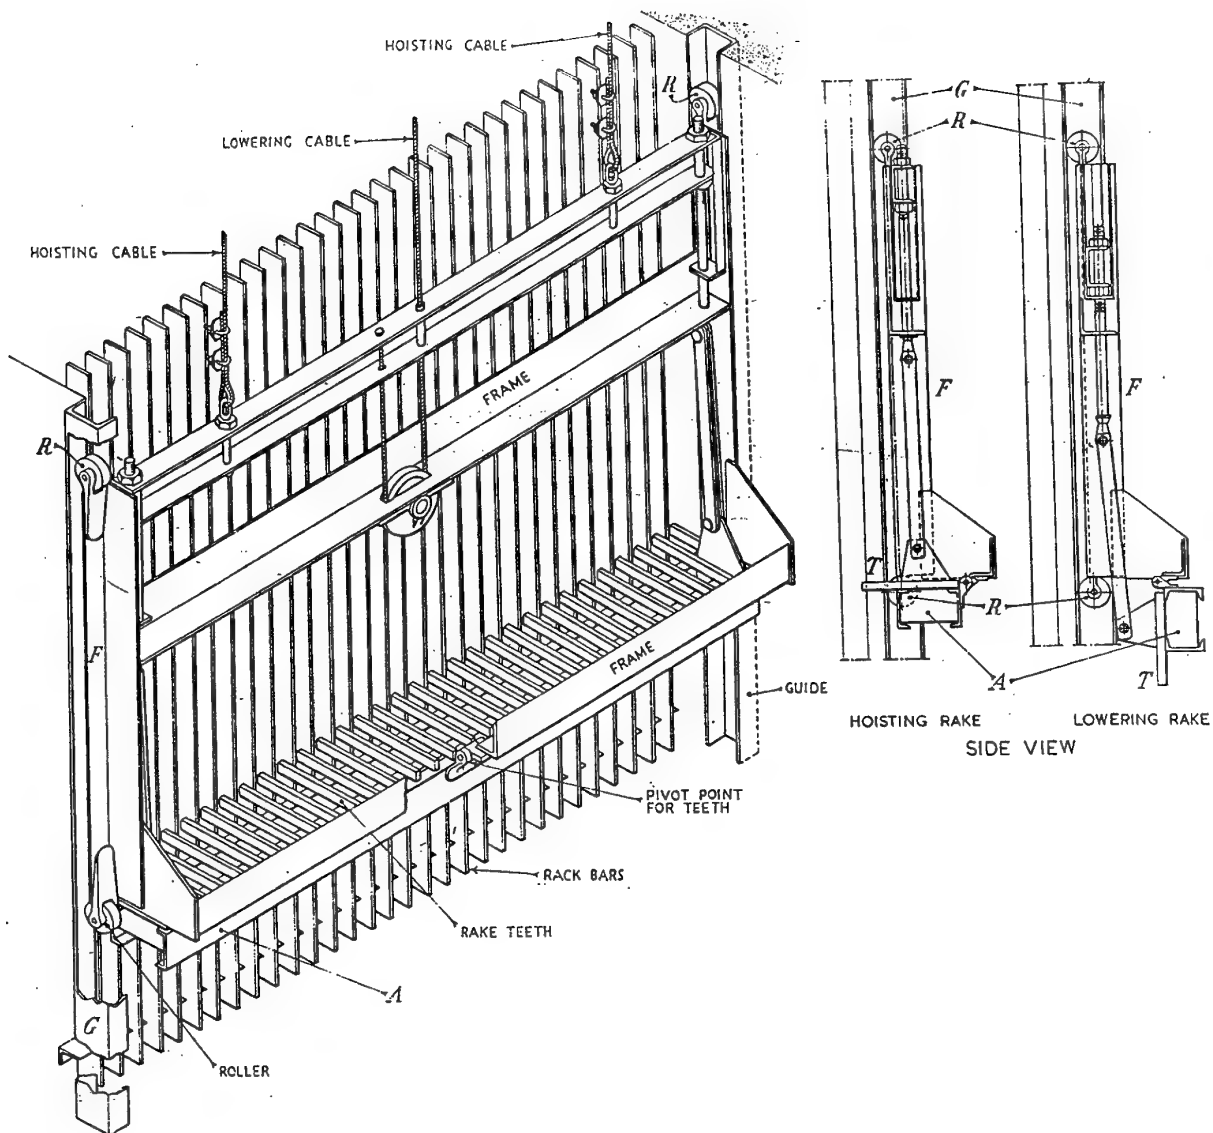
Plate 12 : Newport News mechanical guided trashrack rake (after Zowski, 1960).

2) Guided Mechanical Rakes: This type of rakes requires guides which are usually made of steel embedded in the concrete walls of the intake piers. The rake is guided by rollers or sliding blocks which travel in the channel guides. One of the advantages of the guided rake is that it may readily be used on vertical racks and is not affected by strong transverse currents. Another strong advantage of the guided rake is that it is suitable for use in intakes where the trashrack does not extend up to the operating deck. Disadvantages are that the guides may become obstructed by debris and under severe trash conditions they may need considerable maintenance work. An example of a guided rake is shown in plate 12. This is a Newport News rake and consists of a frame with rollers which travel in guides and a pivoting raking element which is operated by levers linked to the sliding upper beam. The rake is lowered with the teeth

pointing downwards and as the rake reaches the bottom of the rack the mechanical action of the hoist closes it so that the teeth project into the bar-rack spaces.
